CONSERVATION

The Newsletter of the Nottinghamshire Building Preservation Trust Limited

14 – 24 REGENT STREET NOTTINGHAM Main Facade Restoration 1986/87

NEWARK CASTLE

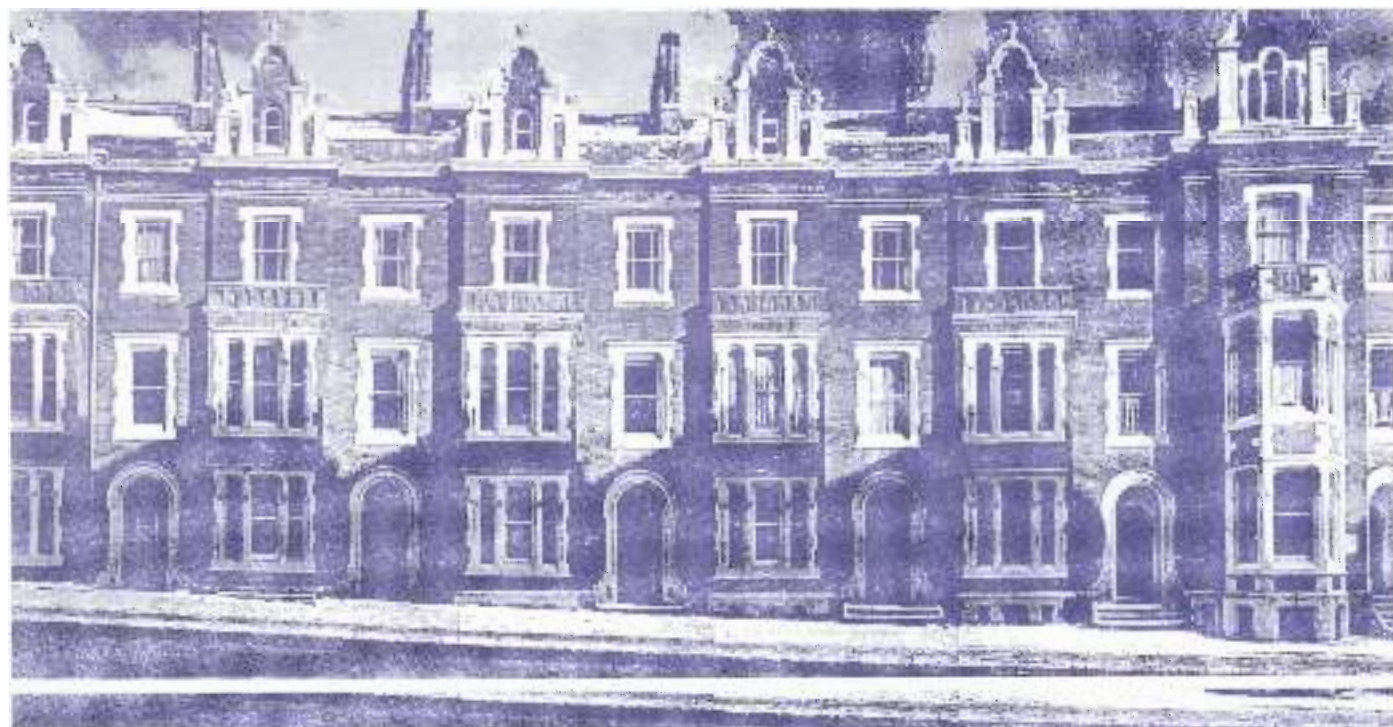
The problems started some years ago but really came to a head when part of the eroded main cornice, at Nr. 20 Regent Street, dangerously fell into the forecourt below. As the premises form part of the Wellington Circus Conservation Area, the Planners were contacted regarding the possibility of grant aid for the necessary repairs. The Planners quickly recognised the importance of the buildings and that the problems with the fabric of Nr. 20 were common to all six properties in the terrace, built about 1850 as prestigious houses for emerging businessmen, by the prominent Nottingham Victorian Architect, T. C. Hine.

The initial study revealed many weathering problems, particularly at roof and parapet levels, due to age, neglect, poor or inadequate maintenance. Quotes for a comprehensive scheme, including the complete restoration of roofs and chimney stacks were unacceptable to the building owners because costs were very high. A less extensive scheme, involving repairs to some stonework at roof level plus the essential rebuilding of the badly eroded brick parapets and built up main cornice, together with brickwork repairs to the facade and some low-budget improvement works at forecourt level, was finally adopted and work started.

One of the major tasks was to replace eroded brickwork sympathetically and unobtrusively. All the shaped brickwork gables were in a poor state and, although sections of the brick parapet had been previously 'repaired', the general condition and appearance was unsatisfactory. The best replacement bricks found were very close in size to the originals but varied slightly in colour and texture. By matching the original bond, selecting a suitable mortar and ensuring that all brickwork joints were maintained as tight as possible to match existing, a reasonable standard has been achieved in the circumstances. Approximately three thousand new bricks were used in the remedial work.

The built up main cornice, at parapet level, was in very poor condition and had to be completely reformed, to follow the original profiles, off the existing brick corbel base which, fortunately, remained in reasonable condition. The work was expertly carried out, using traditional techniques and equipment and the finished result reproduces the crisp and sharp impact at the head of the facade as originally conceived and built. The cornices and bays were all dressed in lead, as an added precaution.

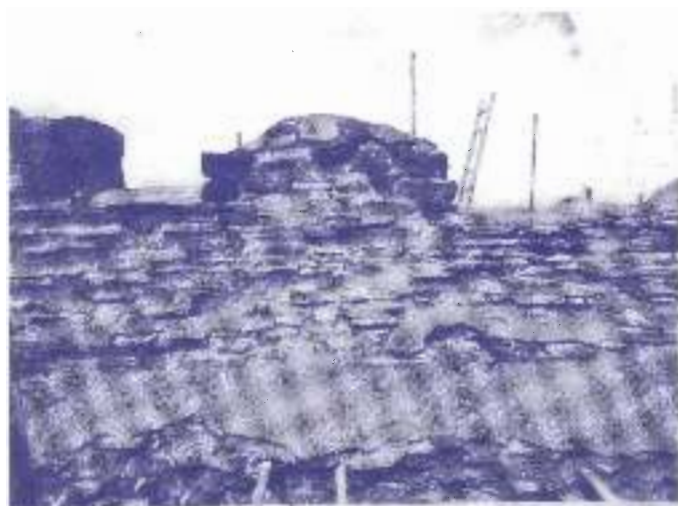
External side showing Merion no. 8 before repair showing the wall work before the core work was completed by the removal of the damaged masonry in the foreground.

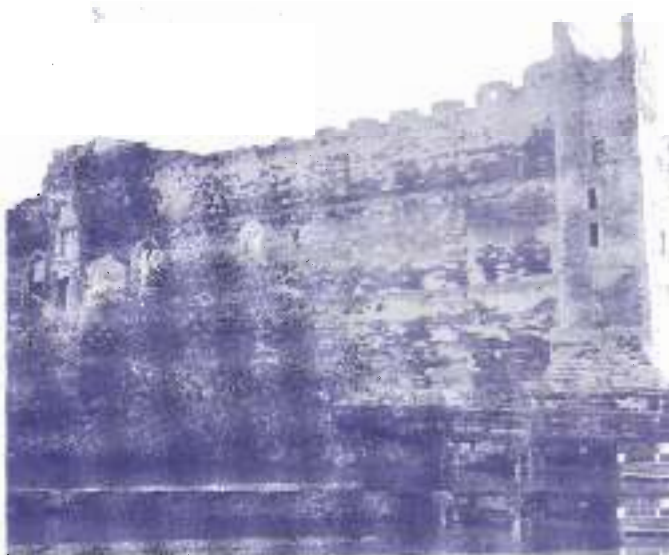
Ashlar side after completion of work.

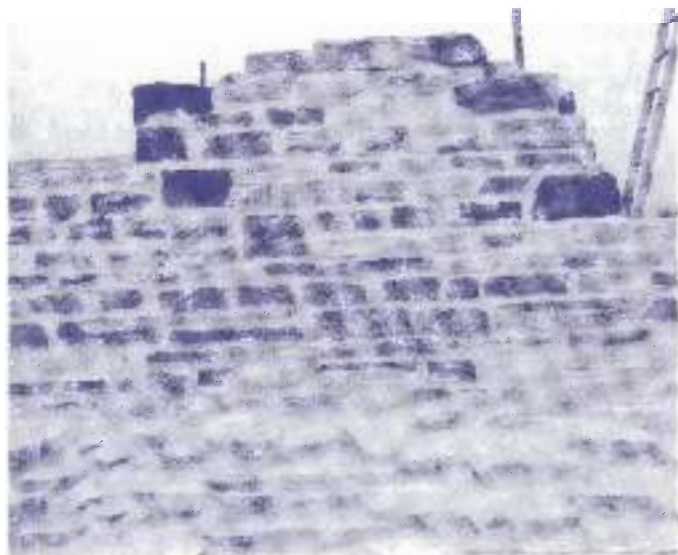
Location no. 5 and base work after repair.

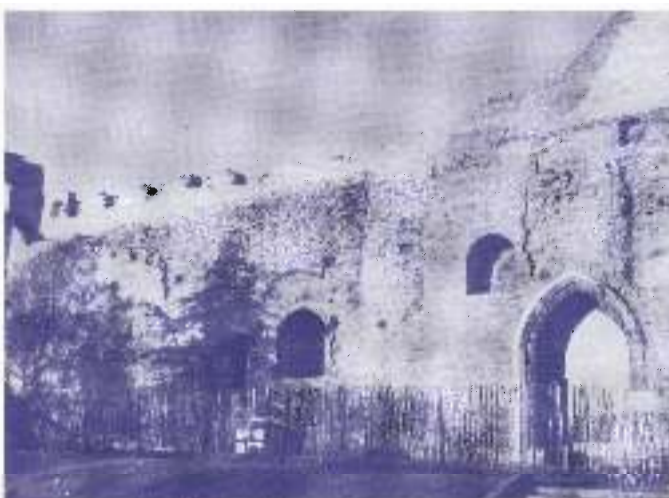
Internal rubble face after completion of work.

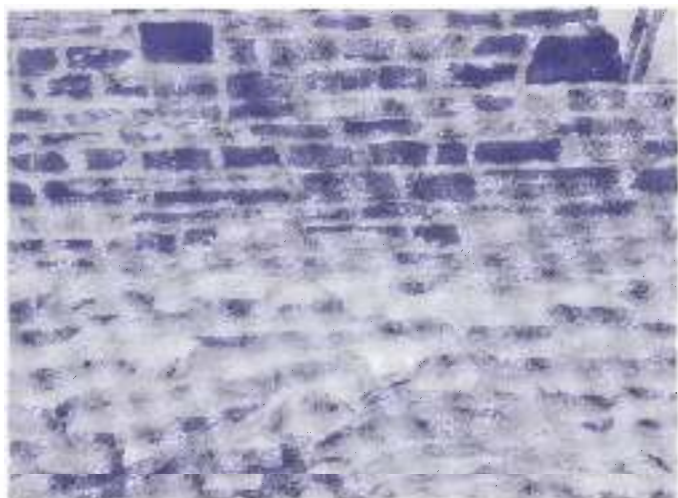
Merion no. 5 and core work after repair.

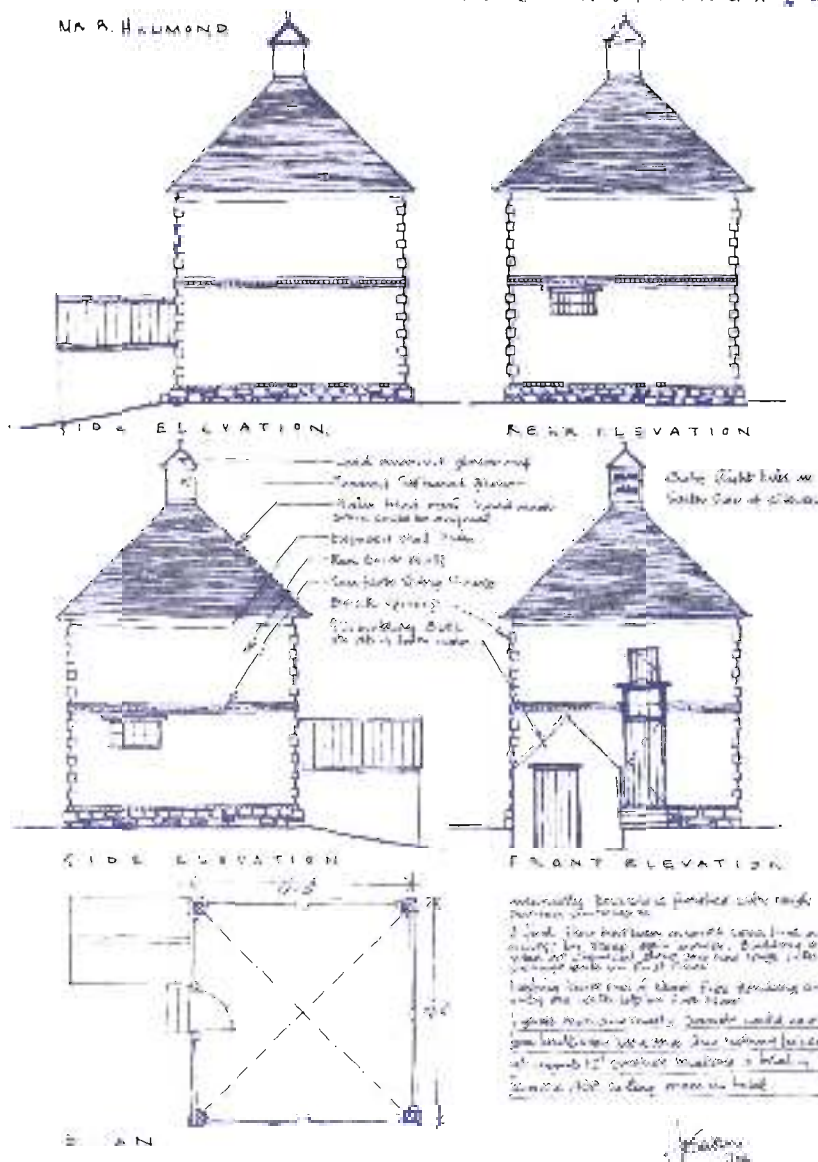
MORTON MANOR DOVECOTE
MORTON CUM FISKEATON NOTTINGHAMSHIRE
MR. R. HAMMOND

The buildings seemed to be little different from when Whitaker saw it when he visited Mr. Richard Wright to view it on 6th August 1927. In his description he says it has a central Glover with eight entrance holes and below a further nine were on top of the wall. These have now gone, no doubt being tiled over after a roof repair.

The repairs carried out in 1987 comprised work to the roof, brick walls and maintenance repair to door, windows and other items.

The roof was stripped to its carcass, all rotten and unstable timbers were replaced, new glovers were constructed and the roof re-battened and tiled. As in the repair at the Bleasby Dovecote, the roof was completed with thicker battens in order to give added strength to some timbers which were 'borderline' for removal and which were retained on the grounds of the historic importance of keeping as much of the original structure as possible.

The brickwork was raked out and re-pointed where necessary and in some cases it was necessary to replace the decayed bricks. A few replacements were provided by Mr. Robert Hammond, the present owner of Morton Manor, and others were acquired through the Nottingham Civic Society's Special Projects Group
