CONSERVATION

The Newsletter of the Nottinghamshire Building Preservation Trust Limited

14 – 24 REGENT STREET NOTTINGHAM Main Facade Restoration 1986/87

NEWARK CASTLE

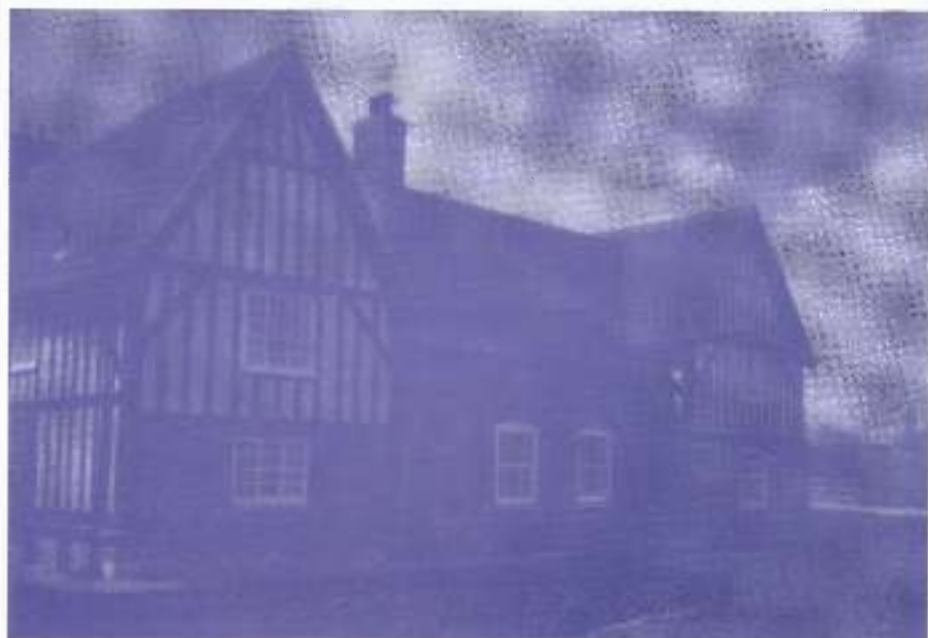
THE GABLES FARM LITTLE CARLTON, Nr. NEWARK

This important, timber-framed building had been standing derelict for many years and had been causing great concern in the Trust, as it had been given over to the housing of pigs and poultry and generally neglected.
